**Players Crossing at Plum Creek Village Homeowners Association, Inc.
C/o Peak to Peak Property Management, LLC
P.O. Box 1808
Castle Rock, CO 80104**

Re: Reserve Analysis, 2014 VERSION

PLAYERS CROSSING AT PLUM CREEK VILLAGE HOMEOWNERS ASSOCIATION

RESERVE ANALYSIS INVENTORY LIST 2014 VERSION

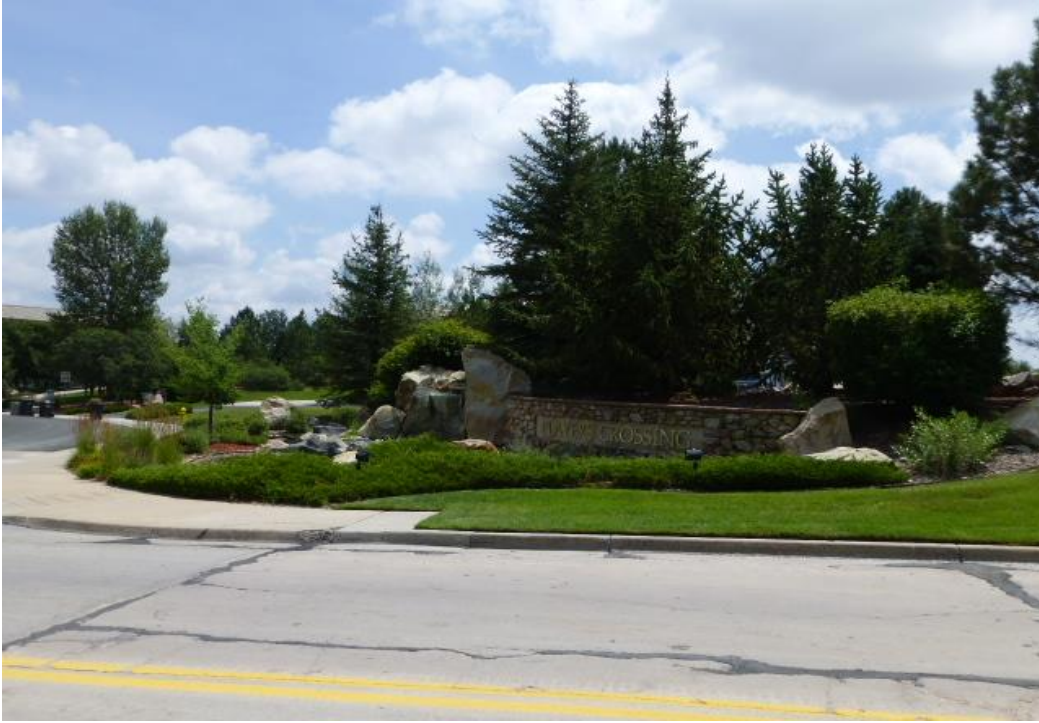
Players Crossing: PICTURE NO. 1: Landscape refurbish and tree replacement will be an issue as Player Crossing continues to age. The large trees are a major asset for the Association.

- A general category to replace or repair, plants, shrubs, and trees in the common area. This category would also include landscape upgrades, landscape improvements, and replacement of the irrigation clocks.

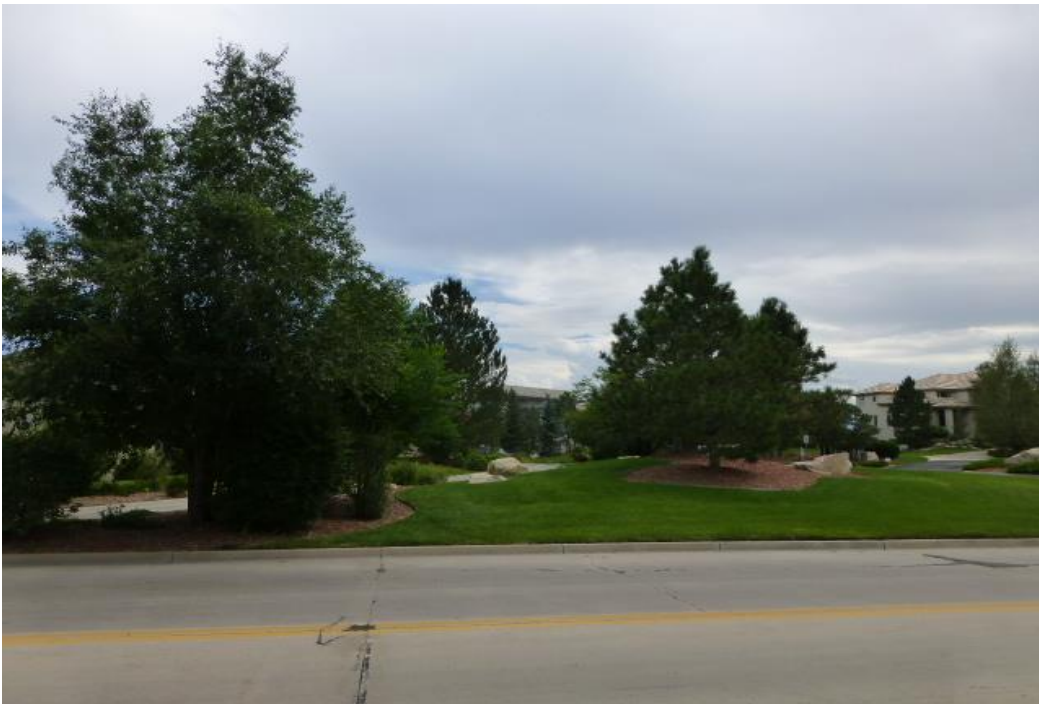
Players Crossing: PICTURE NO. 2: The irrigation system will need to be replaced when the underground pipes weaken from years of use. The expected service life of an irrigation system of this type is 30-35 years.

- A general category to replace the irrigation system. There is approximately 20,183 square feet of irrigated landscaping in the common area at the entrance to the community. Typical life expectancy of an irrigation system is approximately 30-35 years. Eventually the underground pipes and pipe connections begin to fail due to water pressure fatigue.

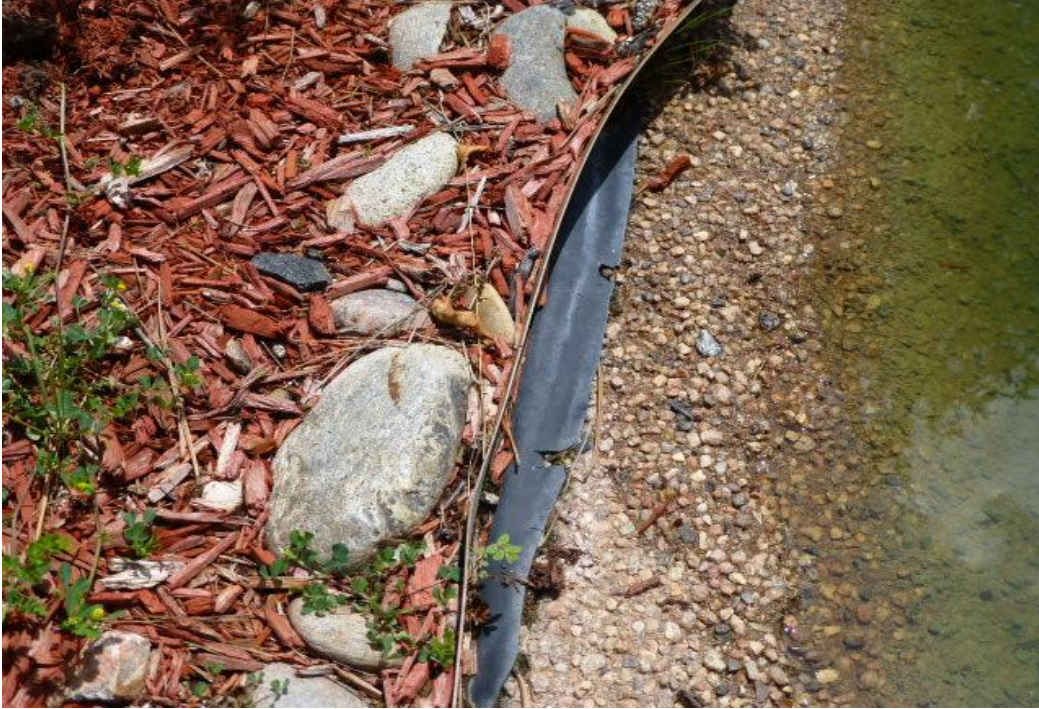
Players Crossing: Picture NO. 3: The waterproofing for the holding ponds of the entrance water feature is a single layer rubber pond or lake liner. This type of liner has an expected service life of 25-30 years.

- The holding ponds of the entrance water feature have a single layer rubber membrane liner buried beneath the rocks and concrete forming the ponds. The rubber liner is the waterproofing element of the ponds. This type of liner has an expected service life of 30-35 years under normal conditions. On going freeze/thaw cycles and the caustic reaction with the surrounding soil will cause the liner to break down and leak. To replace the membrane pond liner the rocks and concrete of the holding ponds will need to be removed and then reinstalled along with a new liner.

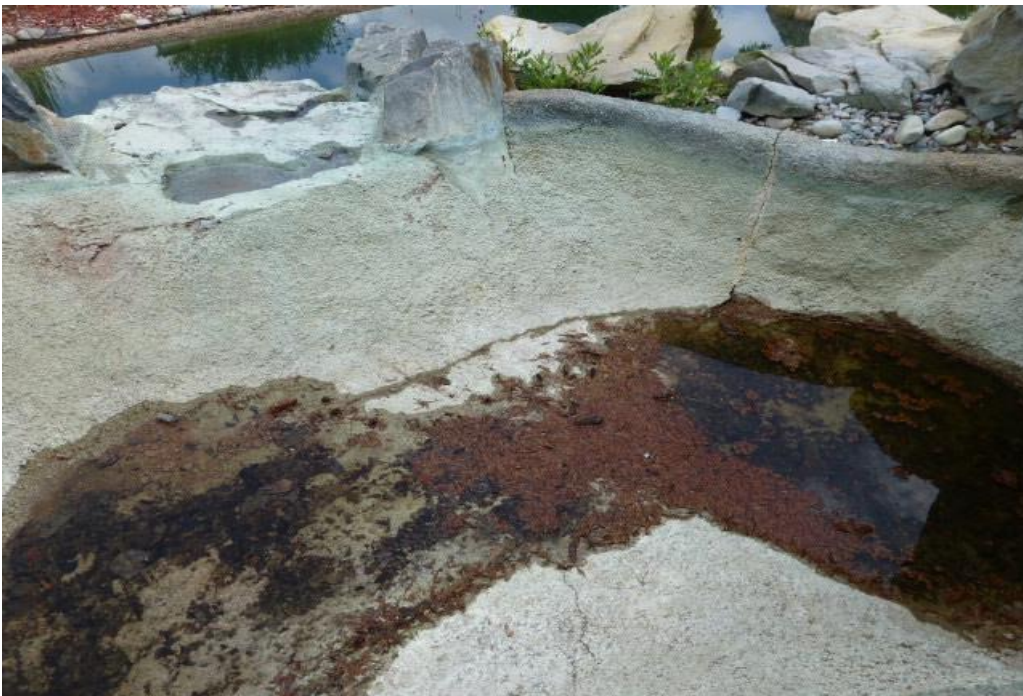
Players Crossing: PICTURE NO. 4: Cracks were observed in the holding ponds which indicate some settling and movement from age and weather cycles. To replace the pond liner the concrete and the rocks of the ponds will need to be removed and reinstalled.

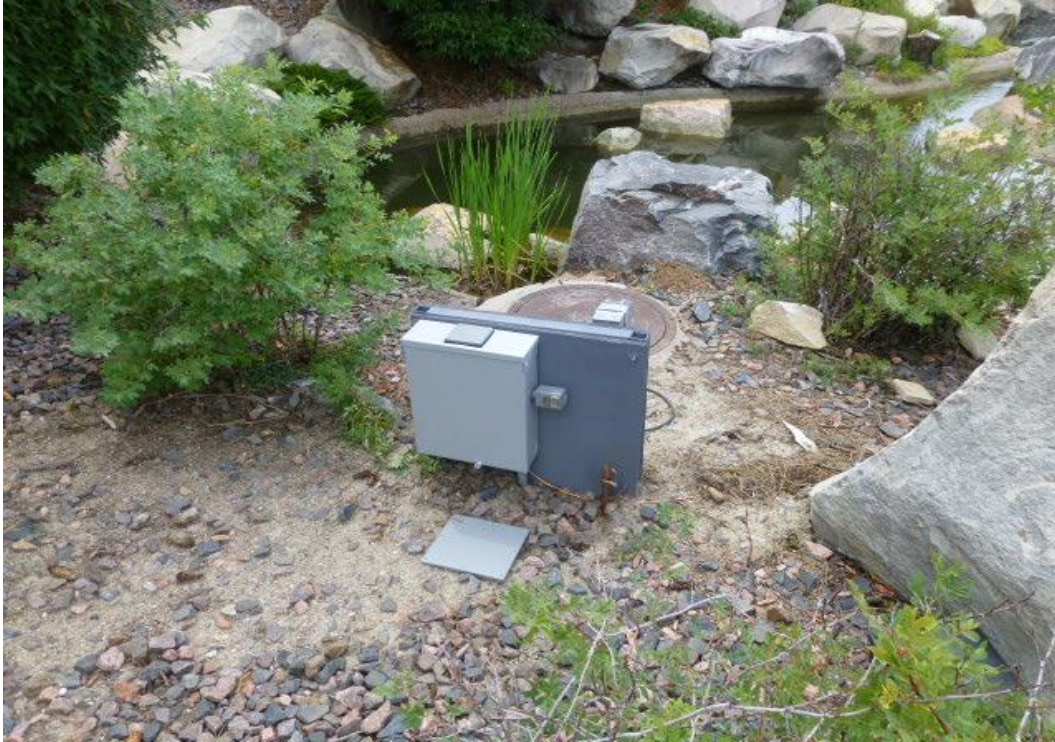
Players Crossing: PICTURE NO. 5: A new electrical panel and pump for the water feature were installed in 2014.

- The electrical service panel and the large water circulation pump were replaced in 2014. This category is a general expense category for future pump replacement and electrical repairs for the entrance water feature.

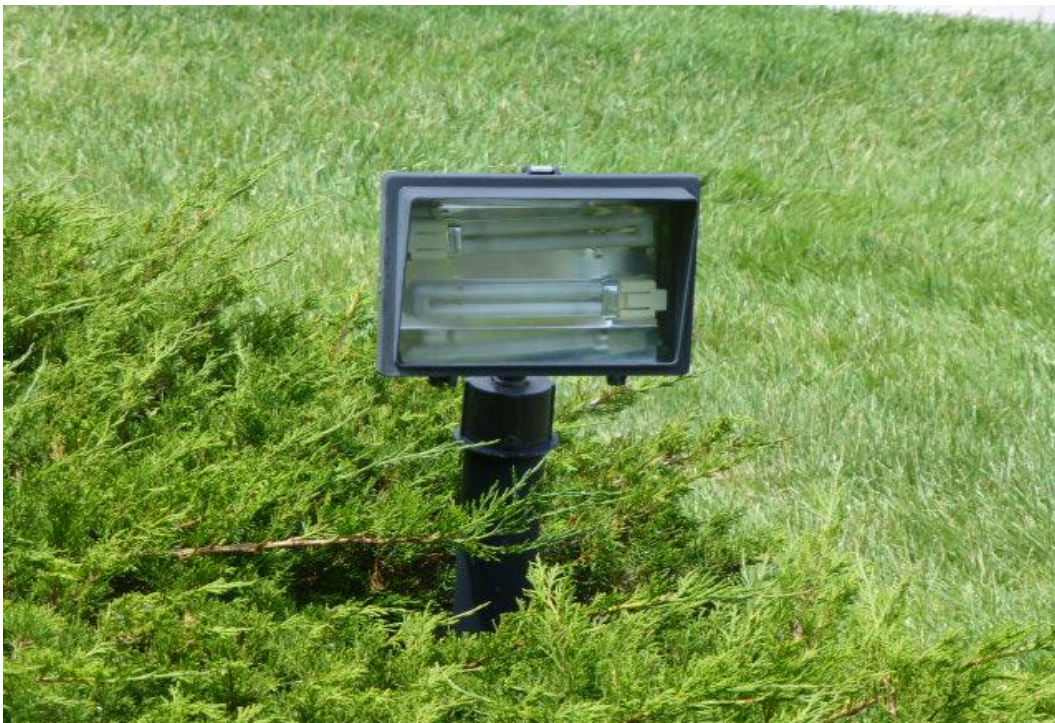
Players Crossing: Picture NO. 6: There are six weather resistant light fixtures at the entrance water feature and monument. The fixtures and wiring will need to be replaced in the future.

- There are six weather proof ground level lights at the water feature. This category is for the future replacement of the light fixtures and wiring for the fixtures.

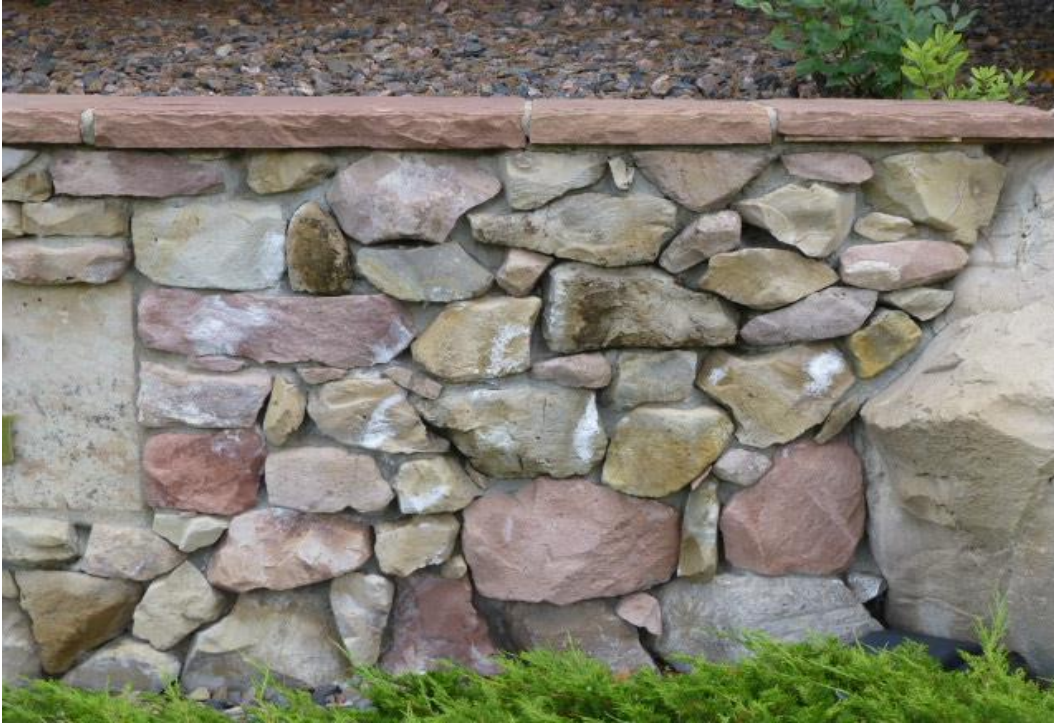
Players Crossing: Picture NO. 7: The entrance monument and sign will need repairs and refurbishing over time. Some areas of the rock wall next to the project identification sign are showing signs of loosening.

- The entrance monument containing the project identification sign, concrete, and stone wall will need replacement and/or repairs in the future.

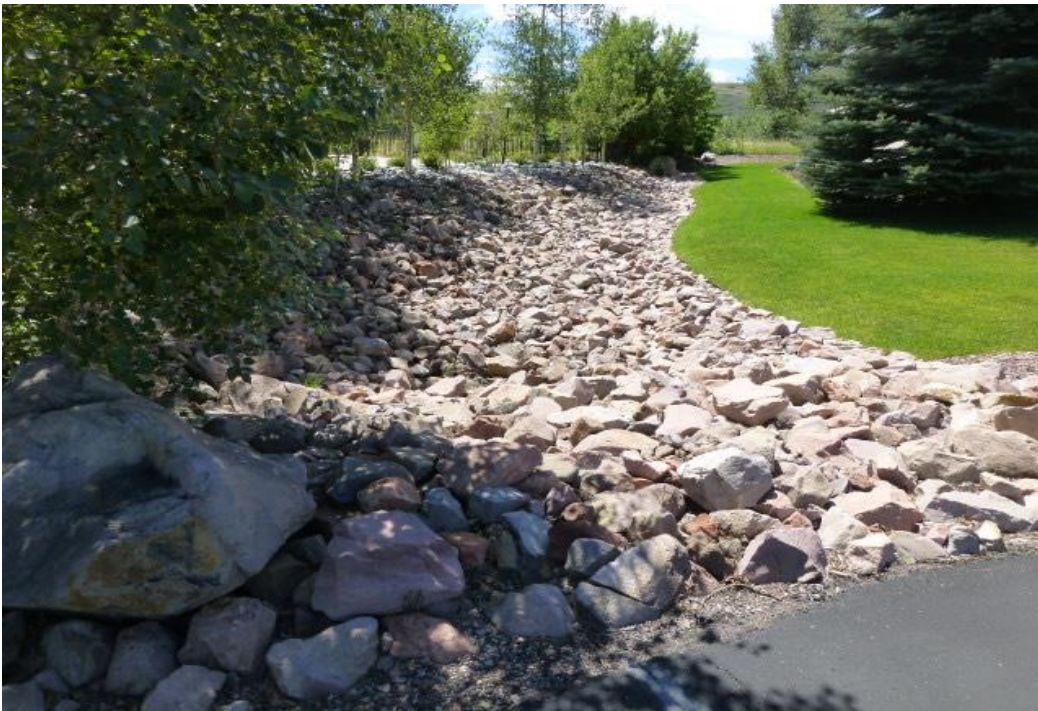
Players Crossing: Picture NO. 8: The Association is responsible for the private drainage easement that runs on lots 1, 2, and 3. The proper functioning of this drainage easement directly impacts these lots, the common area, and the community.

2. According to the recorded plat and the recorded development site plan for the Players Crossing the Association is responsible for a drainage easement that runs along the rear lot lines of lots 1, 2, 3, and between lots 2 and 3. The easement lies with the property lines of these lots. The proper functioning of this drainage easement directly effects the lots and the private access drive serving these lots.

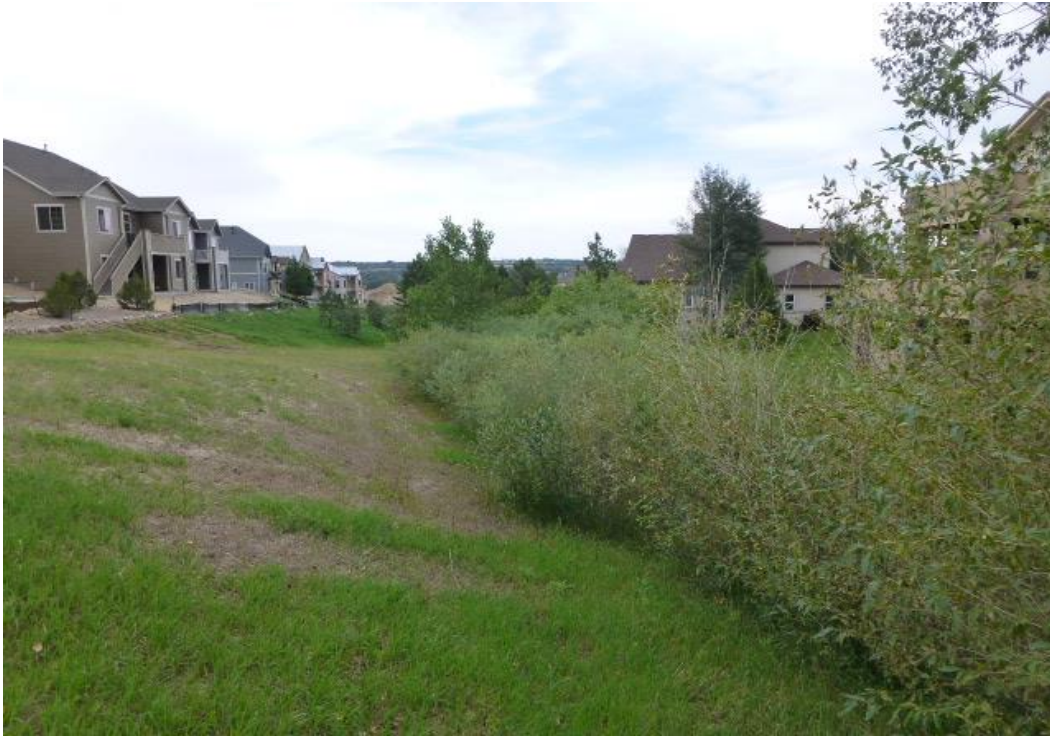
Players Crossing: Picture NO. 9: The Association is responsible for the drainage channel in Tract A. This drainage channel is in common open space that adjoins seven lots on the Northwest side of Players Crossing.

1. The Tract A drainage channel is located along the Northwest side of the project and includes the channel and its entrance into a retention pond on the North side of the community. The rock swale drainage channel in Tract A is severely silted and almost blocked at the storm sewer outflow pipe located at the top of the channel. Also, the rock swale channel is beginning to get clogged by debris and vegetation. At a few locations rocks from the edge of the channel have fallen into the flow line of the channel. The fallen rocks will collect debris and eventually clog the channel. The open edges of the channel where the rocks fell will erode and could eventually impact the lots adjacent to the channel. The proper functioning of this channel and the control of erosion along the channel is a major liability for the Association since the channel borders seven lots.

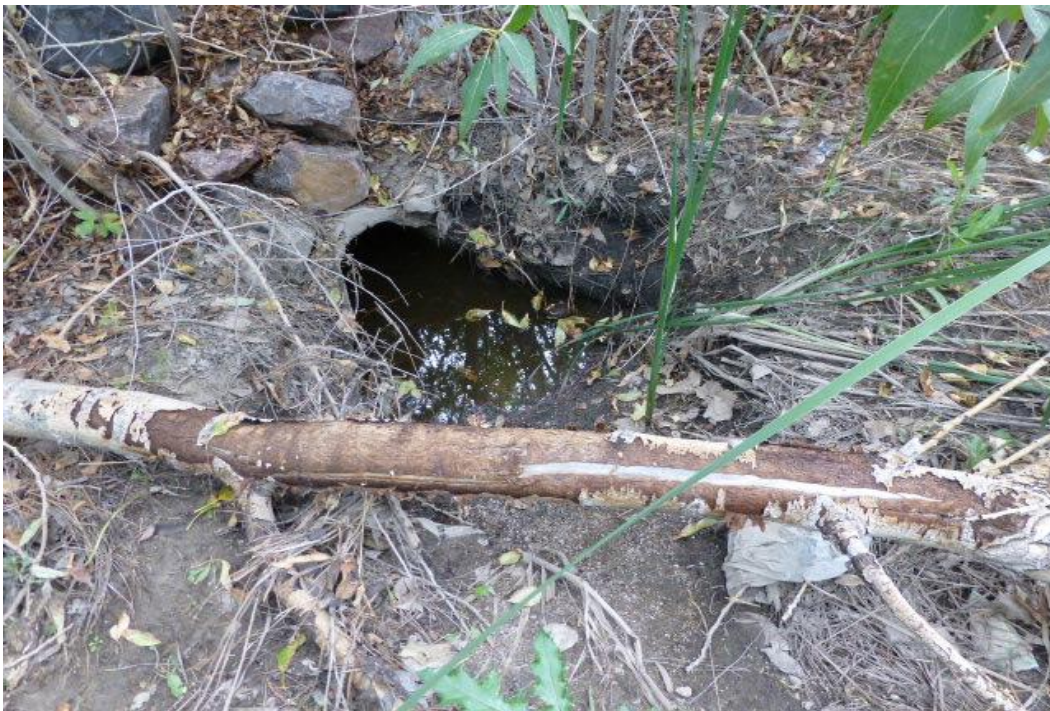
Players Crossing: Picture NO. 10: The storm outlet pipe at the top of the Tract A drainage channel is silted and partially blocked by silt, debris, and vegetation.

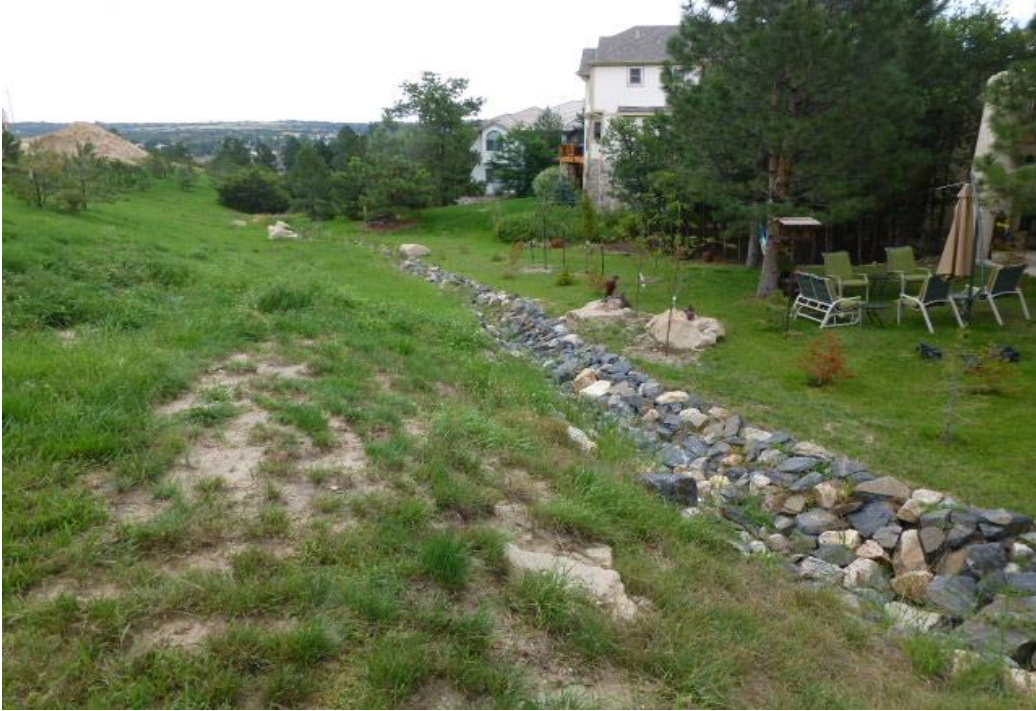
Players Crossing: Picture NO. 11: The Association is responsible for the rock drainage channel and the erosion control in Track A.

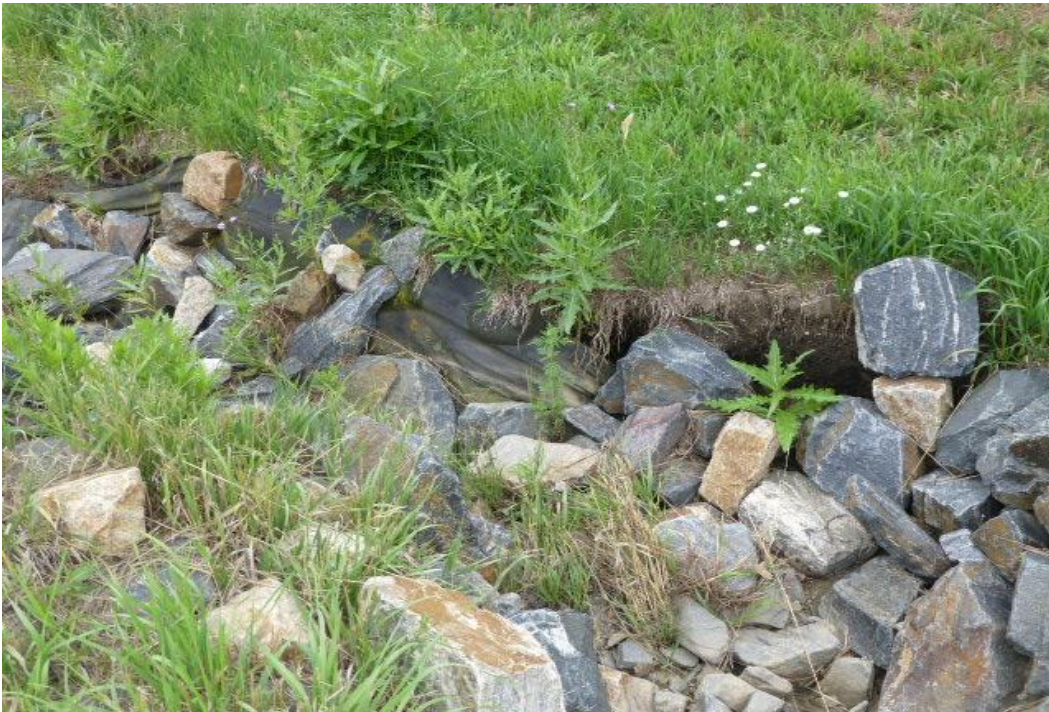
Players Crossing: Picture NO. 12: Rocks from the edge of the drainage channel have fallen into the flow line of channel which will compromise the proper functioning of the drainage patterns. Also, erosion of the edges of the channel will impact the property adjacent to the channel.

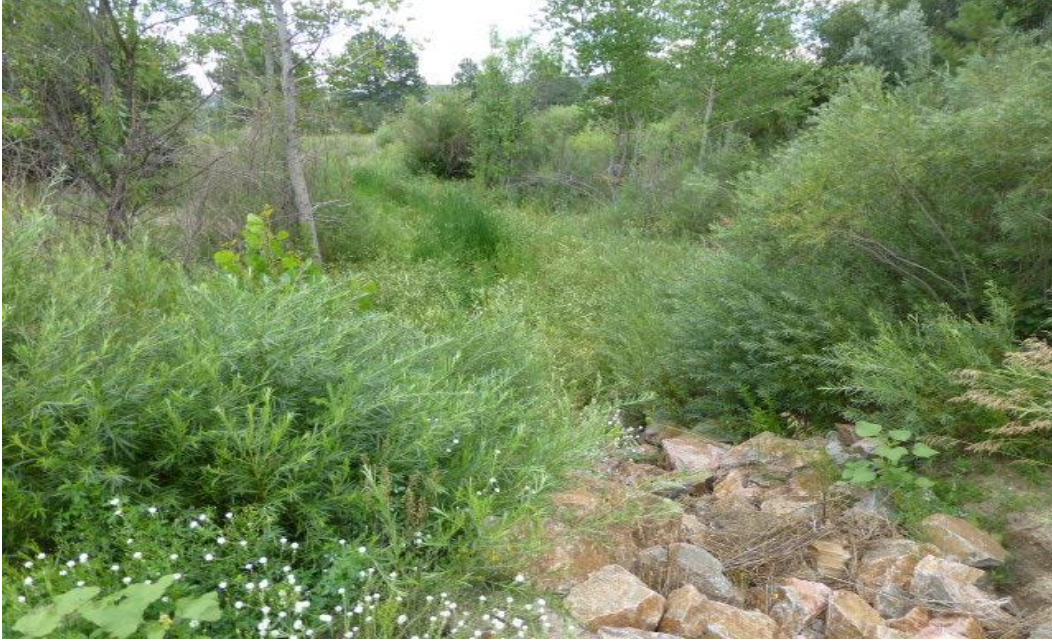
Players Crossing: PICTURE NO. 13: The Town of Castle Rock recently repaired and improved their portion of the retention pond where the Association's drainage channel enters the retention pond.

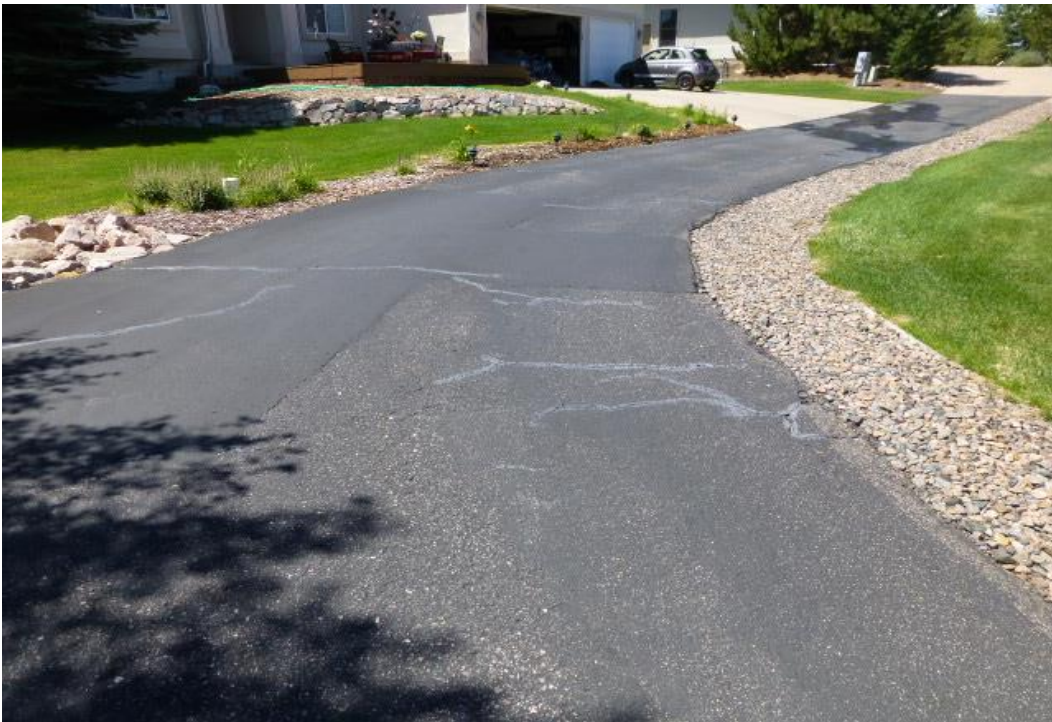
Players Crossing: PICTURE NO. 14: Per recorded documents with the Douglas County, the Association owns the private access drive that services lots 1, 2, and 3. The Association has a legal opinion regarding lots 1, 2, and 3 providing maintenance for this drive, but legally the drive is still owned by the Association per the recorded documents.

- The recorded Planned Development Site Plan and the recorded Plat for Players Crossing describe Tract E as as private access drive and common area serving lots 1, 2, and 3 that is owned and maintained by the Association. The Association has obtained a letter from the Association's legal counsel stating the maintenance of the drive should be a shared expense of lots 1, 2, and 3. The future replacement of the drive could fall on the Association since the recorded Planned Development Site Plan labels Tract E as a private access, utility, and drainage easement that is owned and maintained by the Homeowners Association. This category in the reserve analysis is for the future replacement of the drive and does not include the normal maintenance of the asphalt such as sealing and patching.
